# 7 Cedars Public Water System Jamestown S'Klallam Tribe May 21, 2014

James Earl, P.E.
Tribal Utility Consultant
Indian Health Service
Spokane District Office
528 E Spokane Falls Blvd Suite #302
Spokane, Washington 99202
(509) 455-3561

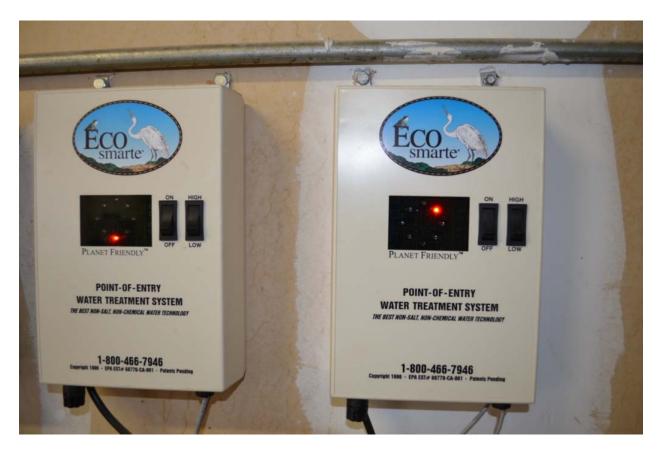
Eco Smarte treatment system controls

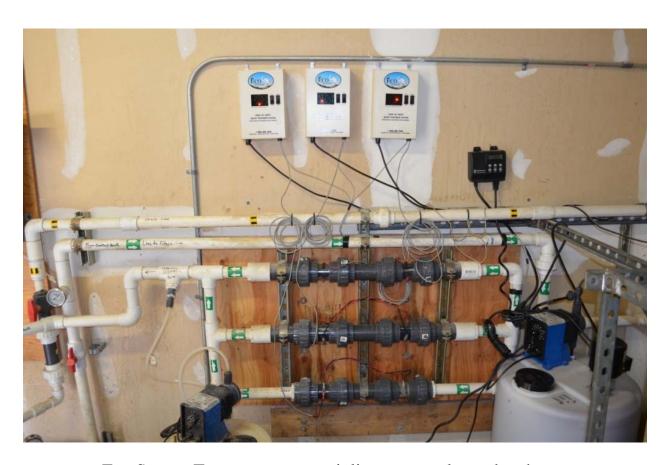
A telephone interview with Eco Smarte technical assistance staff on May 20<sup>th</sup> indicated that potassium permanganate addition was not compatible or recommended. The technical assistance staff also indicated that the potassium permanganate could be dissolving the copper from the electrodes and contributing to elevated copper levels.

The technical staff went on to state that part of the treatment technology of the Eco Smarte system is to elevate dissolved copper levels to help discourage the growth of pathogens; however, the treatment system is designed to keep the copper levels well below the EPA action level of 1.3 mg/L. The Eco Smarte literature indicates that the maximum expected copper level as a result of their treatment technology is about 0.7 mg/L. The technical staff indicated that copper levels above 0.7 mg/L could be a result of the action of the potassium permanganate on the copper electrodes.

Eco Smarte Treatment system, inline copper electrodes shown

The addition of potassium permanganate should be discontinued due to the potential for corroding the copper electrodes in the Eco Smarte treatment system. If, after discontinuing the potassium permanganate addition, iron and manganese levels are unacceptable from the current source water, Eco Smarte should be consulted to identify a potential malfunction of the treatment system. Eco Smarte stated that the treatment system has sufficient capacity to reduce iron and manganese levels adequately without the addition of potassium permanganate.

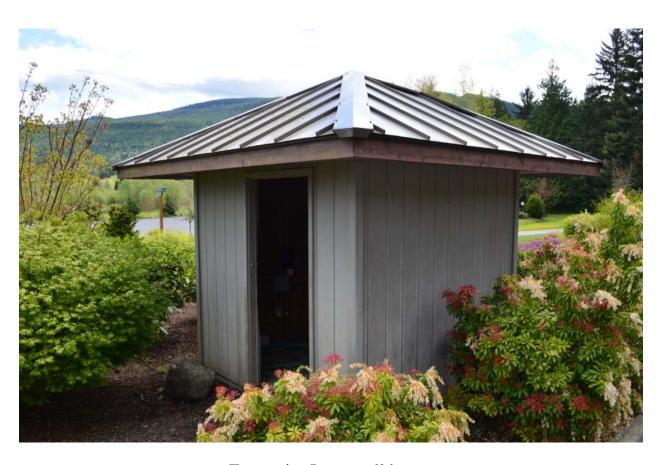
Enterprise Lane well house

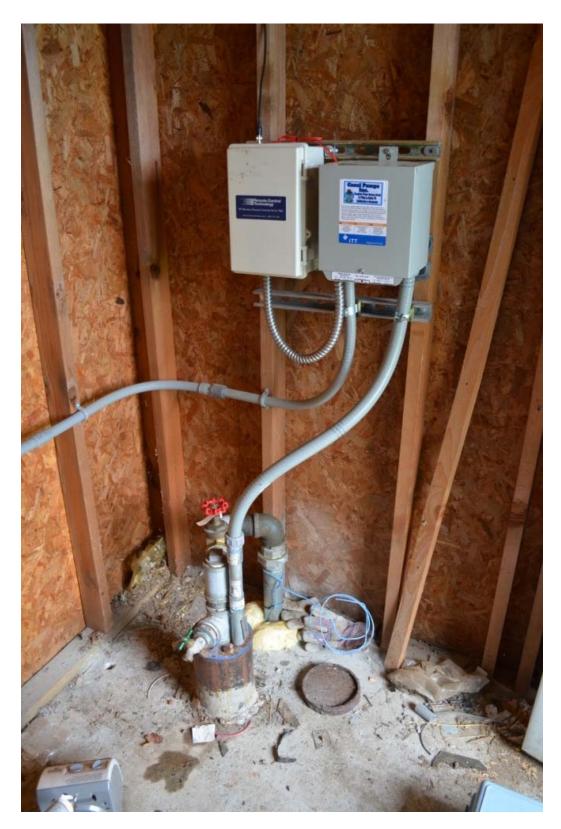
Enterprise Lane well head and controls

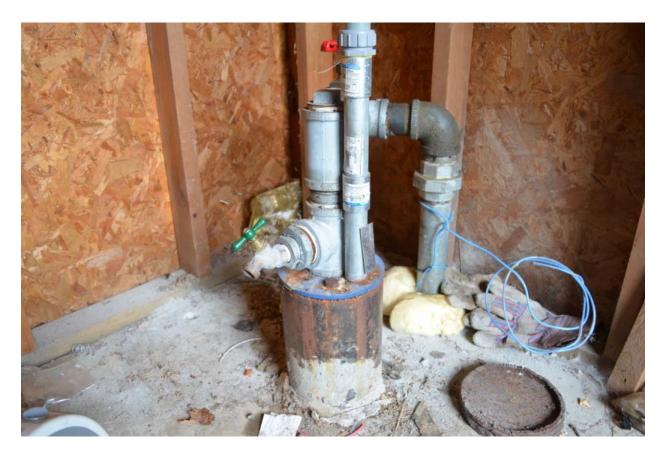
Well cap lacks screened vent. Well cap must be fitted with a screened vent to meet EPA standards.

Several improvements will need to be performed on the Enterprise Lane well to meet EPA standards if the system owners choose to use it as their source well. The casing is too short, so it will need to be extended to a minimum of 18 inches above the surface of the slab. The well cap needs to have an approved screened vent installed. EPA guidance for well casing length and approved well caps is attached in Appendix D.

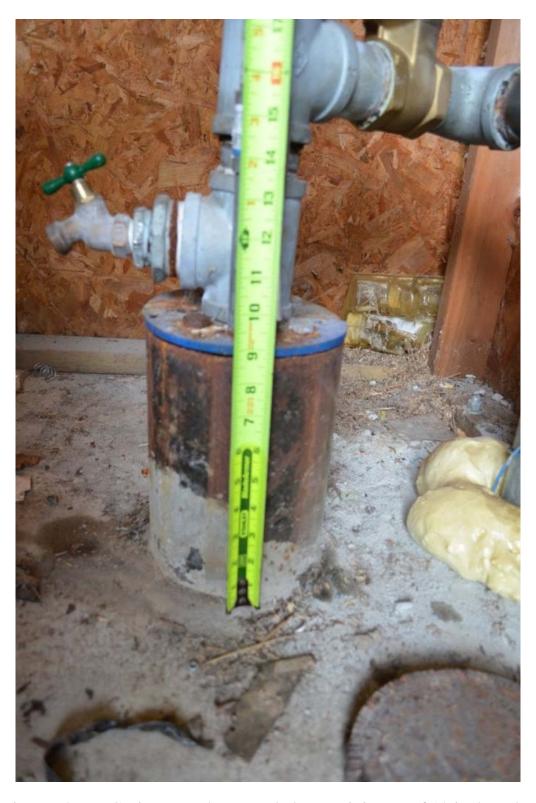
Casing is too short. Casing must be extended to a minimum of 18 inches above the slab to meet EPA standards.
